**Flood Control Project Maintenance  
Levee Inspections  
LMA District Cover Sheet  
Spring 2010 Levee Inspection Results**

**Sacramento Maintenance Yard West Levee Yolo Bypass**

**Levee Inspection Report By Mile - Spring 2010**

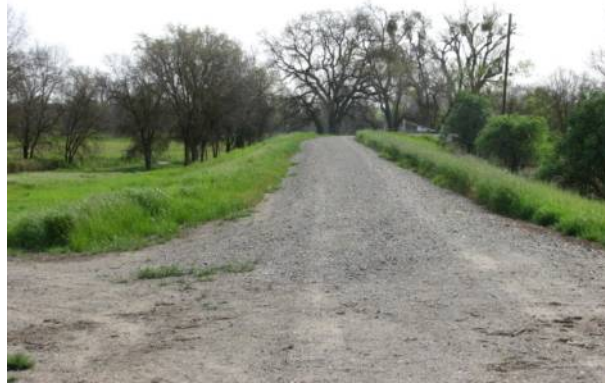
johnngw\_s\_20100325\_061.jpg

Levee Mile Report Line	1
Start Levee Mile	0.00
End Levee Mile	2.71
Location	Water Side
Category	Earthen Levee
Item	Vegetation

Tall grasses 12" or taller

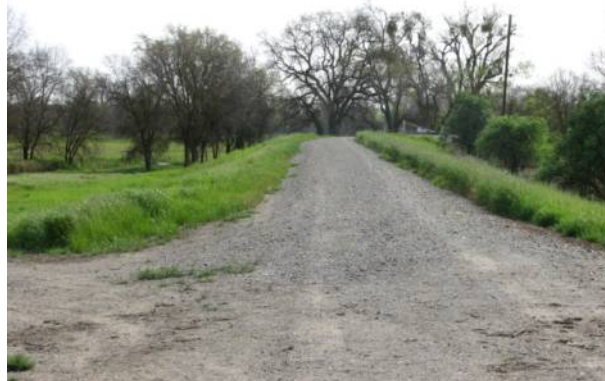
johnngw\_s\_20100325\_062.jpg

Levee Mile Report Line	2
Start Levee Mile	0.00
End Levee Mile	2.71
Location	Land Side
Category	Earthen Levee
Item	Vegetation

12" or taller

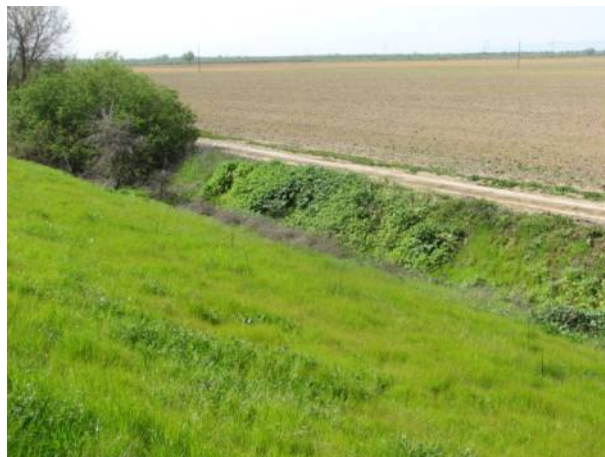
johnngw\_s\_20100325\_065.jpg

Levee Mile Report Line	3
Start Levee Mile	0.94
End Levee Mile	1.82
Location	Land Side
Category	Earthen Levee
Item	Encroachments

Agricultural ditch at toe of landside levee

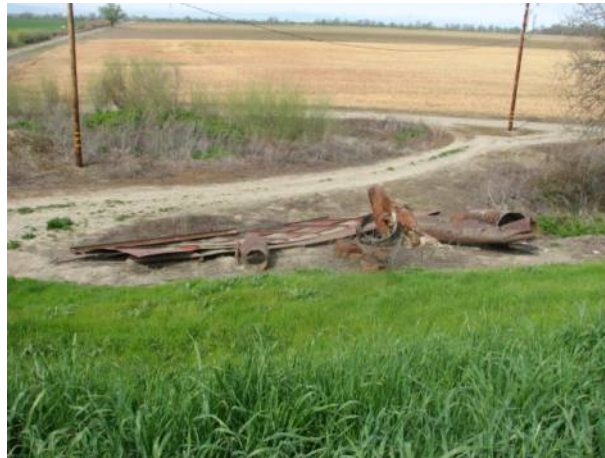
johngw\_s\_20100325\_066.jpg

Levee Mile Report Line	4
Start Levee Mile	1.83
End Levee Mile	1.83
Location	Land Side
Category	Earthen Levee
Item	Encroachments

scrap metal at toe of landside levee

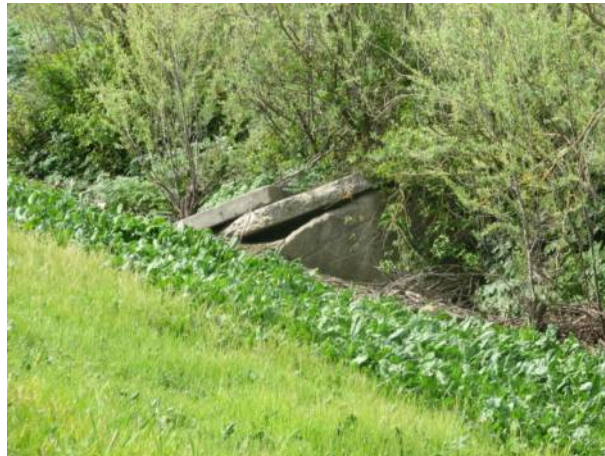
johngw\_s\_20100325\_067.jpg

Levee Mile Report Line	5
Start Levee Mile	1.85
End Levee Mile	1.85
Location	Land Side
Category	Earthen Levee
Item	Encroachments

old concrete cuvert box at toe of landside levee

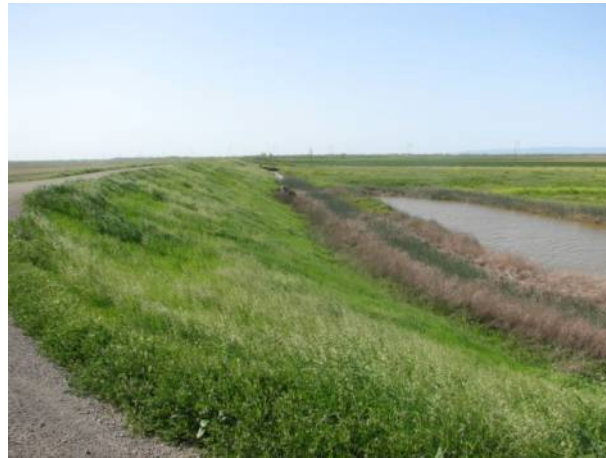
johngw\_s\_20100324\_050.jpg

Levee Mile Report Line	3
Start Levee Mile	0.08
End Levee Mile	0.21
Location	Land Side
Category	Earthen Levee
Item	Encroachments

borrow pit and agricultural ditch

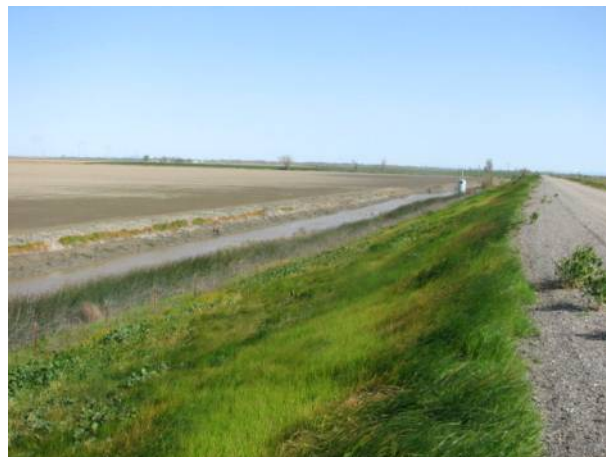
johngw\_s\_20100324\_051.jpg

Levee Mile Report Line	4
Start Levee Mile	0.47
End Levee Mile	0.97
Location	Land Side
Category	Earthen Levee
Item	Encroachments

Agricultural ditch

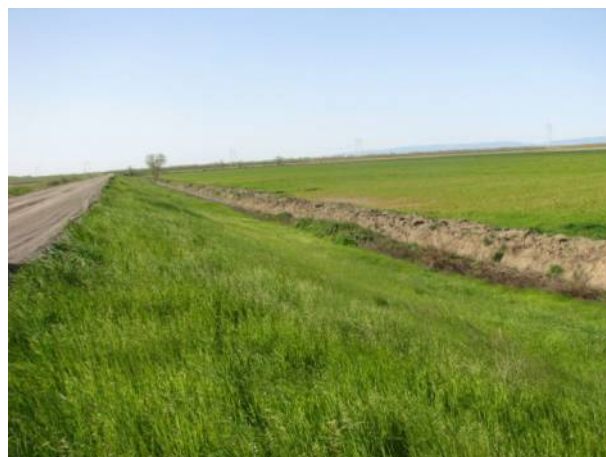
johngw\_s\_20100324\_052.jpg

Levee Mile Report Line	5
Start Levee Mile	1.15
End Levee Mile	1.44
Location	Land Side
Category	Earthen Levee
Item	Encroachments

Agricultural ditch

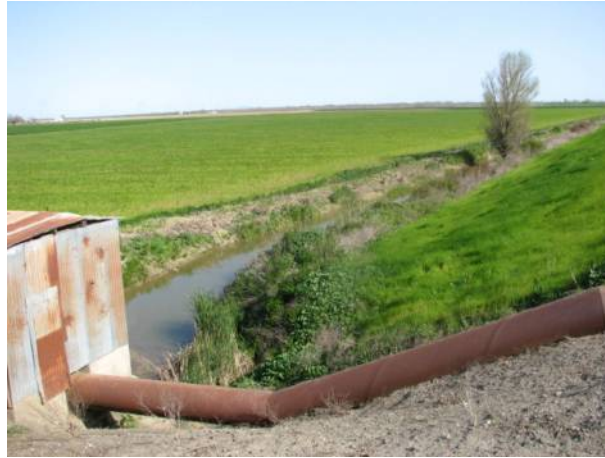
johngw\_s\_20100324\_053.jpg

Levee Mile Report Line	5
Start Levee Mile	1.15
End Levee Mile	1.44
Location	Land Side
Category	Earthen Levee
Item	Encroachments

agricultural ditch and pump

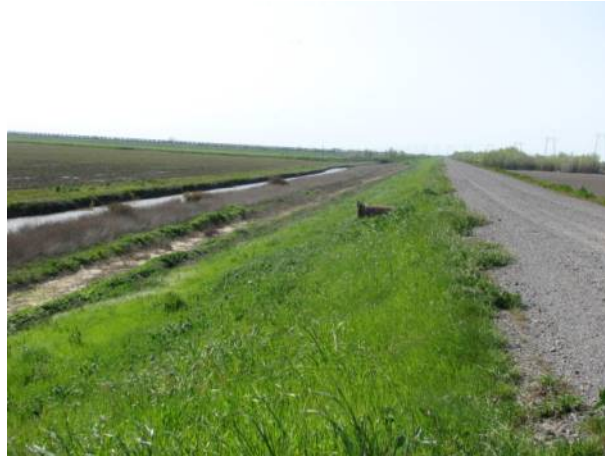
Levee Mile Report Line	1
Start Levee Mile	0.00
End Levee Mile	0.78
Location	Land Side
Category	Earthen Levee
Item	Vegetation
vegetation, grasses mow or burn	
johnngw_s_20100324_055.jpg

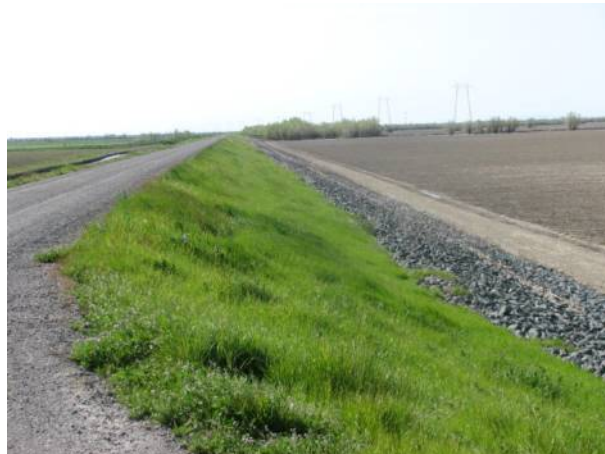
Levee Mile Report Line	2
Start Levee Mile	0.00
End Levee Mile	0.78
Location	Water Side
Category	Earthen Levee
Item	Vegetation
vegetation grasses mow or burn	
johnngw_s_20100324_054.jpg

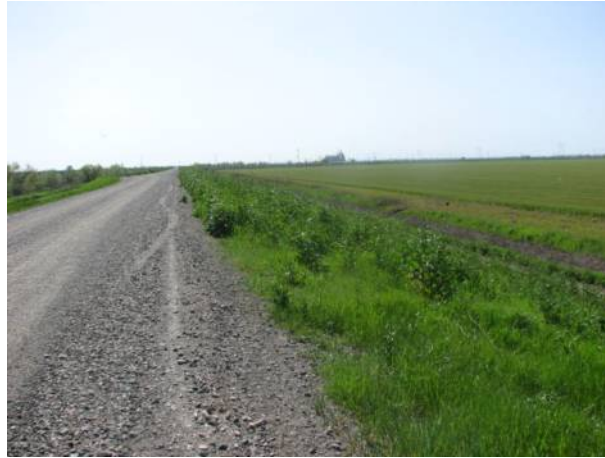
Levee Mile Report Line	1
Start Levee Mile	0.00
End Levee Mile	3.60
Location	Land Side
Category	Earthen Levee
Item	Vegetation
vegetation 12" or taller	
johngw_s_20100325_072.jpg

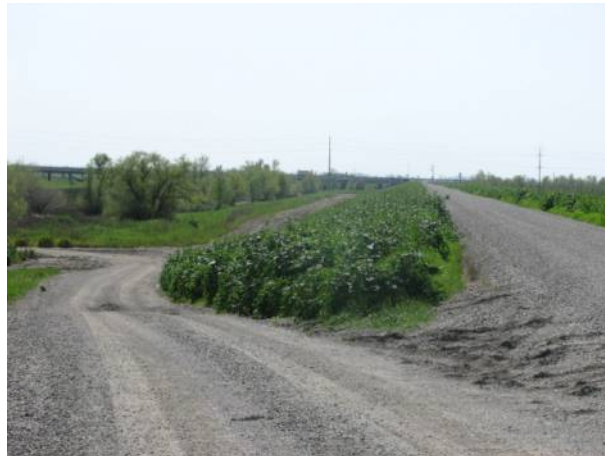
Levee Mile Report Line	2
Start Levee Mile	0.00
End Levee Mile	3.59
Location	Water Side
Category	Earthen Levee
Item	Vegetation
waterside vegetation	
johngw_s_20100325_073.jpg

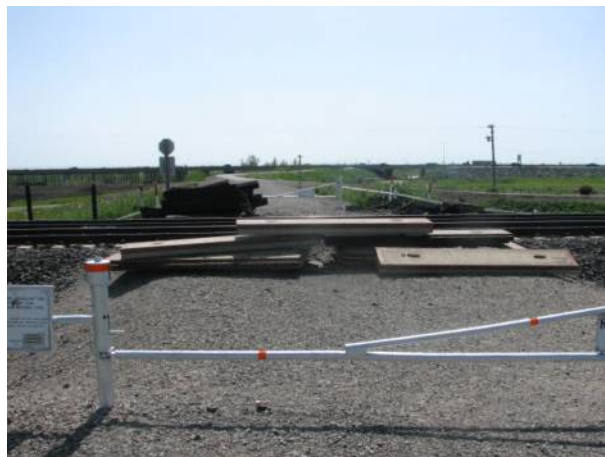
Levee Mile Report Line	3
Start Levee Mile	0.57
End Levee Mile	0.57
Location	Crown
Category	Earthen Levee
Item	Encroachments
changing railroad ties out; crown blocked	
johngw_s_20100325_074.jpg

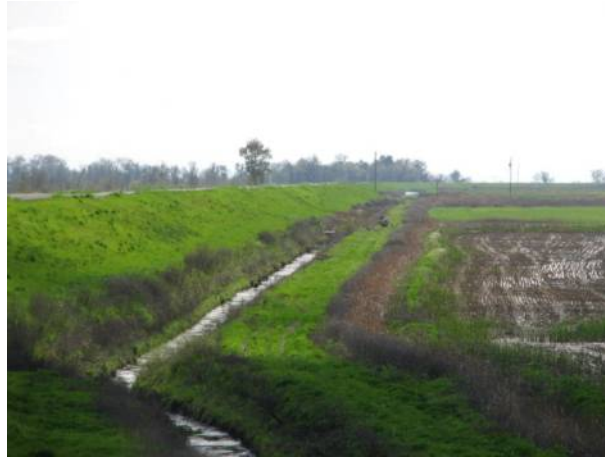
johngw\_s\_20100316\_043.jpg

Levee Mile Report Line	4
Start Levee Mile	1.78
End Levee Mile	2.70
Location	Land Side
Category	Earthen Levee
Item	Encroachments

ag drain LM 1.78-2.70

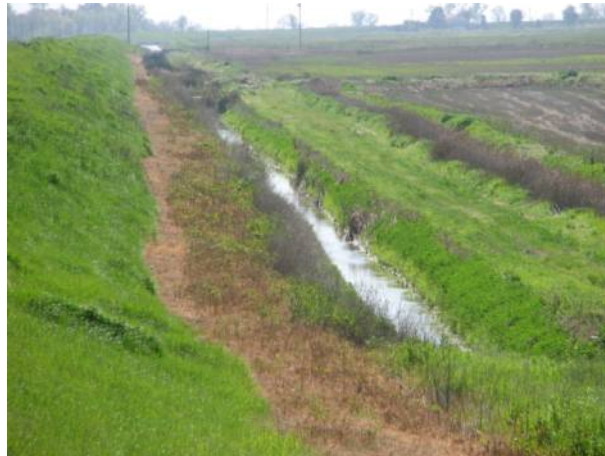
johngw\_s\_20100325\_075.jpg

Levee Mile Report Line	4
Start Levee Mile	1.78
End Levee Mile	2.70
Location	Land Side
Category	Earthen Levee
Item	Encroachments

landside toe

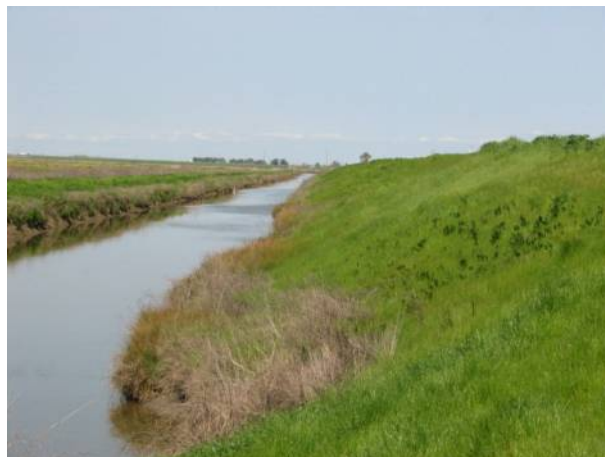
johngw\_s\_20100316\_044.jpg

Levee Mile Report Line	5
Start Levee Mile	2.76
End Levee Mile	3.60
Location	Land Side
Category	Earthen Levee
Item	Encroachments

ag drain LM 2.76-3.60

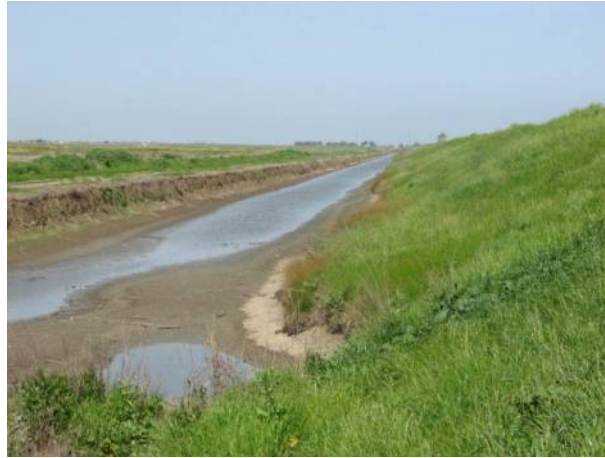
johngw\_s\_20100325\_076.jpg

Levee Mile Report Line	5
Start Levee Mile	2.76
End Levee Mile	3.60
Location	Land Side
Category	Earthen Levee
Item	Encroachments

landside toe
